Re: #14547  
Additional Floors on Existing Garage  
Methodist Hospital  
Brooklyn, NY

## SCHEMATIC FUTURE BUILDING EXTENSION PLAN

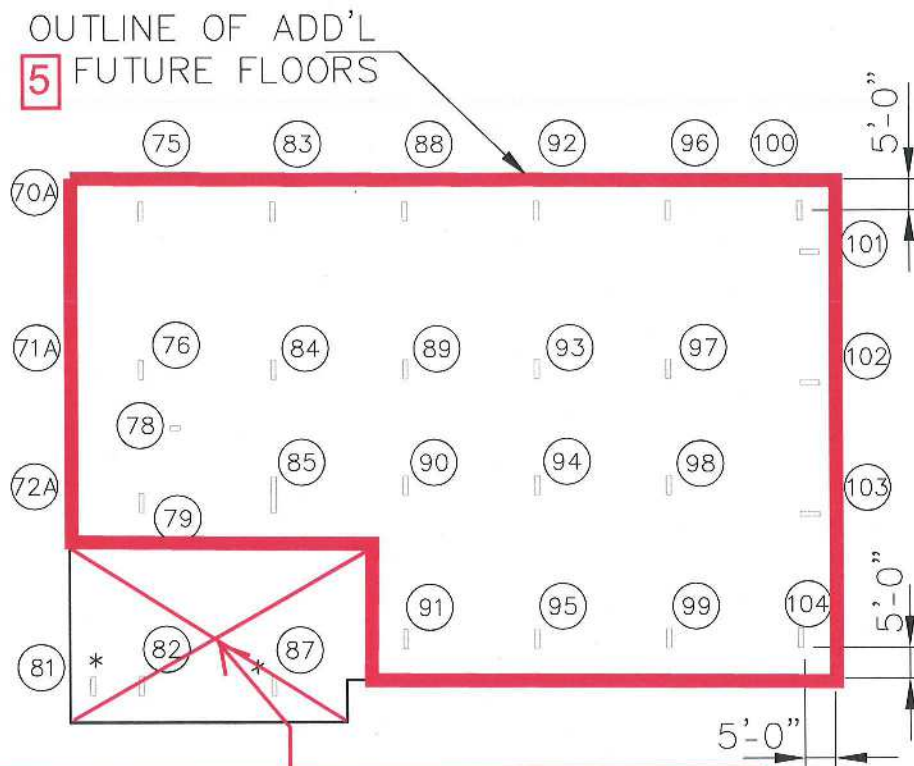
Since transfer girders supporting columns 81, 82 and 87 were not designed for future floors, the future garage floors must be stepped as shown.
