Re: New York Methodist Hospital
Center for Community Health
505-525 6th Street (Block 1084,
Lots 25, 26, 28, 39-44, 46, 48,
50-59, 164, 1001, and 1002)
BSA Cal. No. 289-13-BZ

1. *Provide studies for lesser variance options for the Center that (i) fully comply with the applicable height and setback regulations in the R7B district and (ii) reduce the degree of the building's non-compliance with the applicable height and setback regulations in the R6B district.*

NEW YORK METHODIST HOSPITAL CENTER FOR COMMUNITY HEALTH

LESSER VARIANCE STUDY

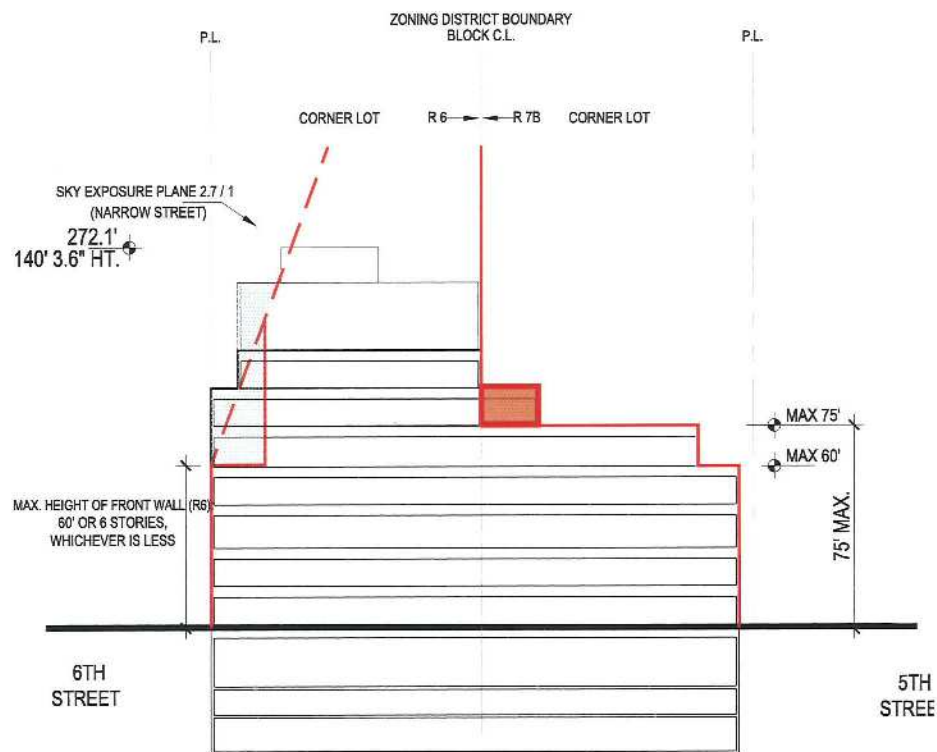
CORNER LOTS C & D: R6 / R7B

- AREAS OF NON-COMPLIANCE
- SKY EXPOSURE PLANE
- PERMITTED BUILDING ENVELOPE

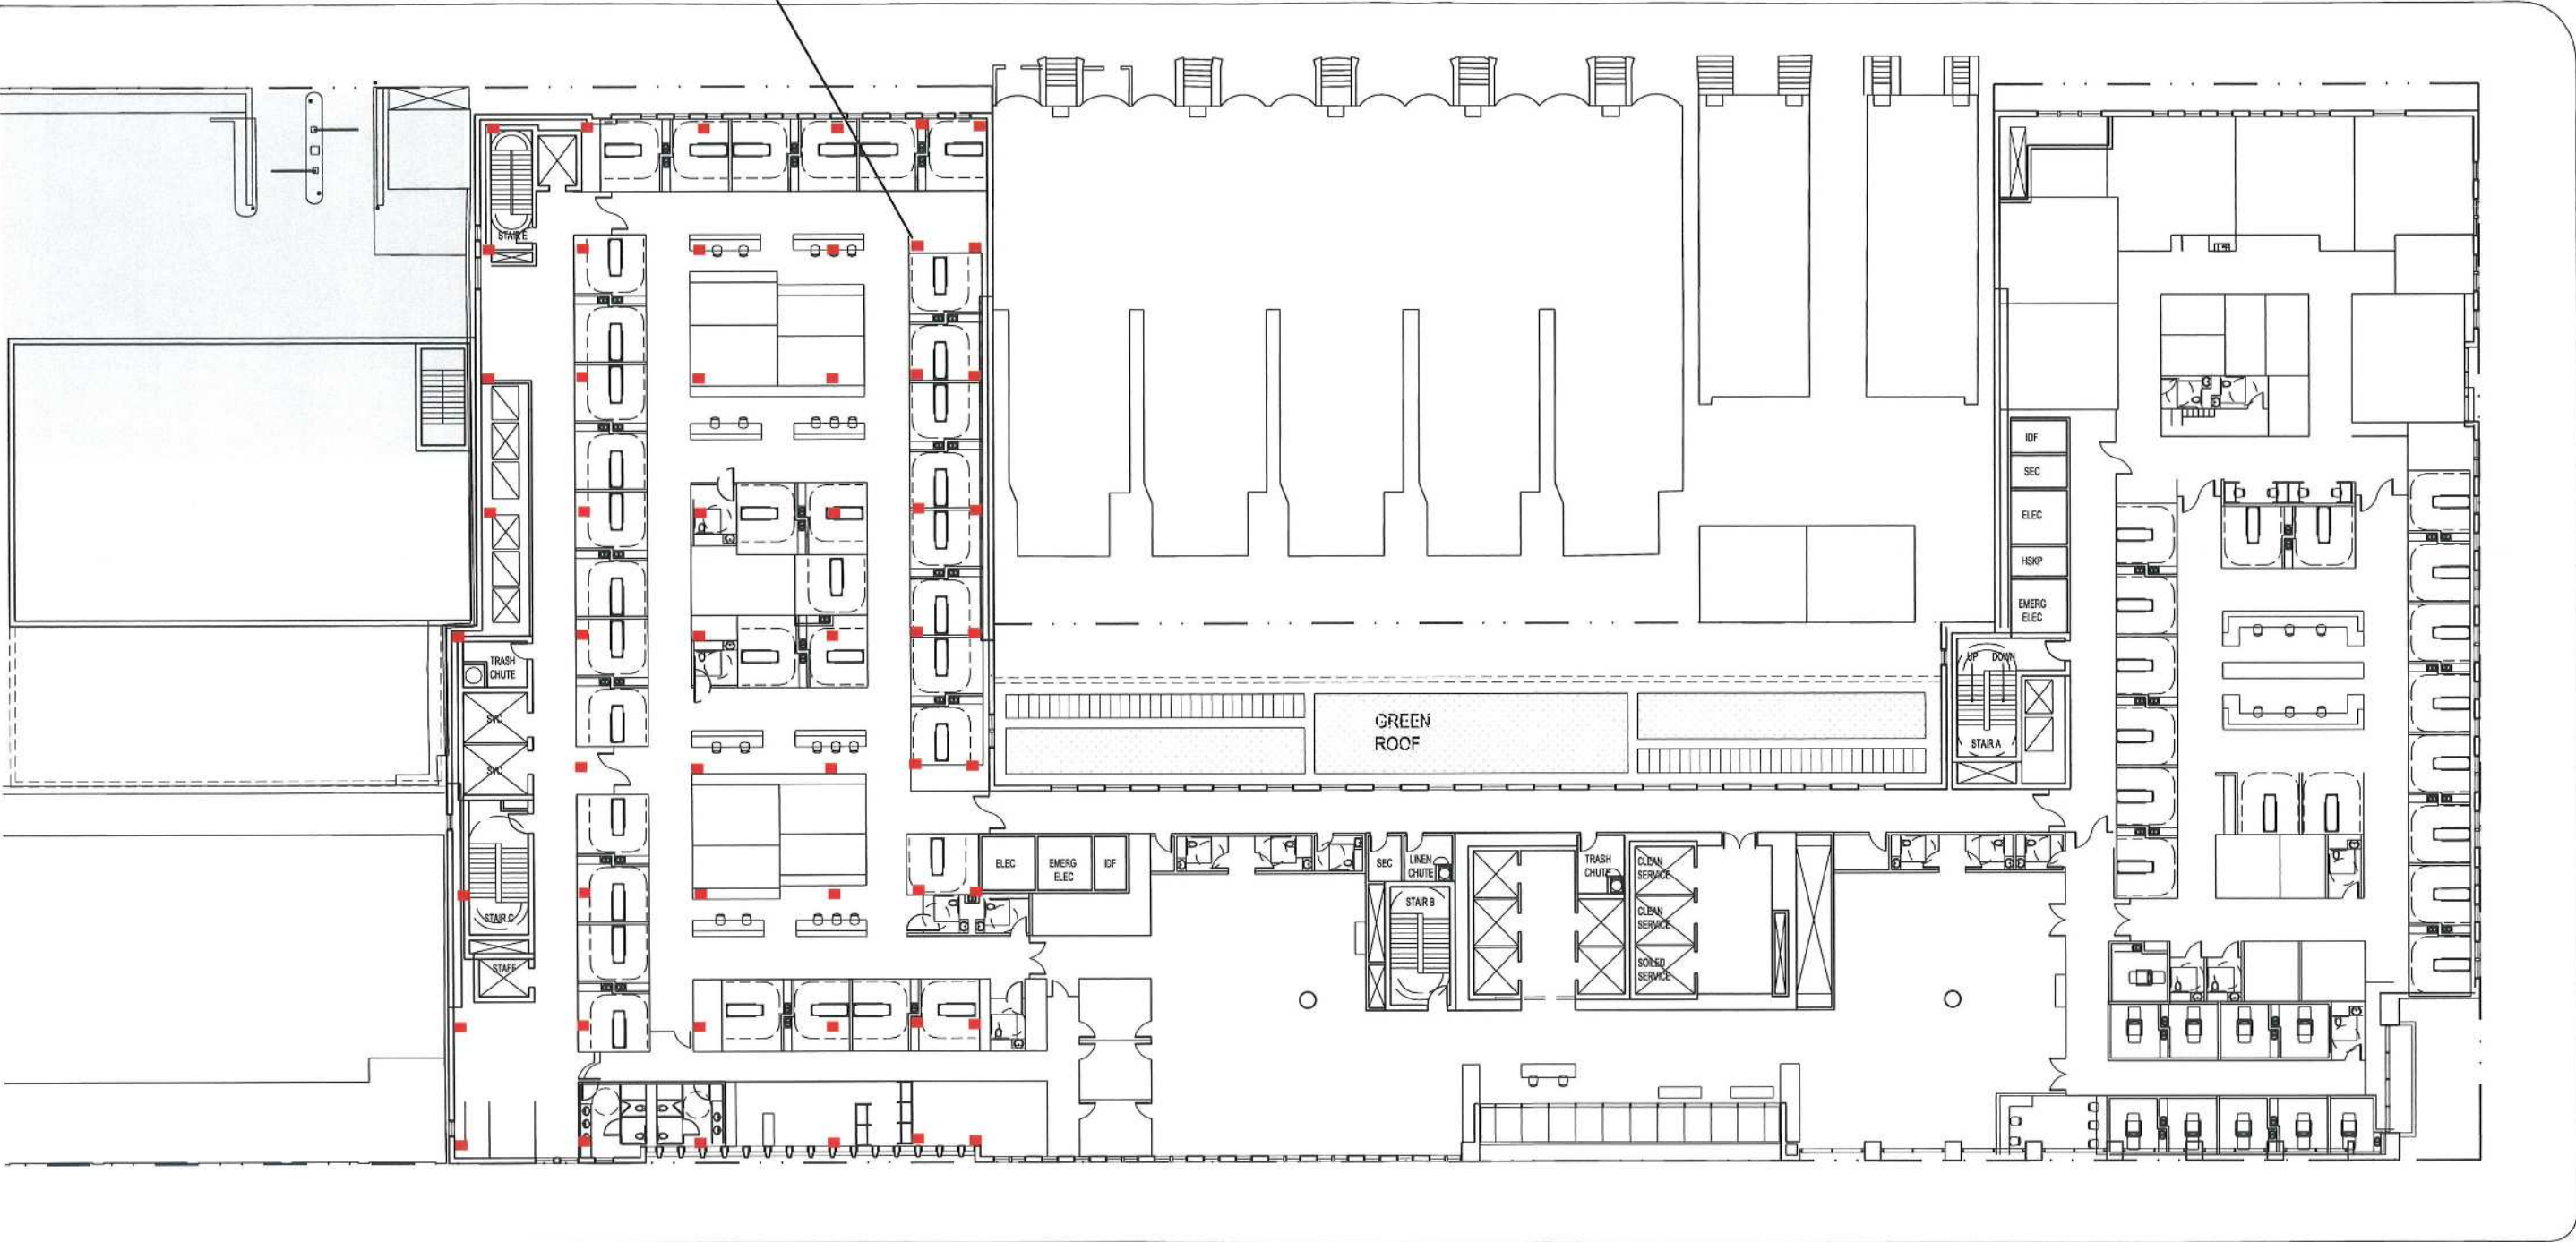
Compromised / Displaced
PACU due to denser column
grid for Surgical Suite above

PACU and Special Procedures relocated from Fourth Floor

- As an alternative to maintaining standard-depth beams and denser column spacing on the 2nd floor, the building could be designed with a deeper 3rd floor construction to achieve the floor stiffness required for the surgical suite. This would take the form of deeper structural framing members, spanning between fewer, farther-spaced columns than in the above option, to provide the stiffness required for the surgical floor. This solution results in either a greater floor-to-floor height for the floor and, in turn, the building, or a reduced headroom condition on the 2nd floor, with its associated loss of flexibility, compromised design, and complex coordination, maintenance, and construction, as described below.

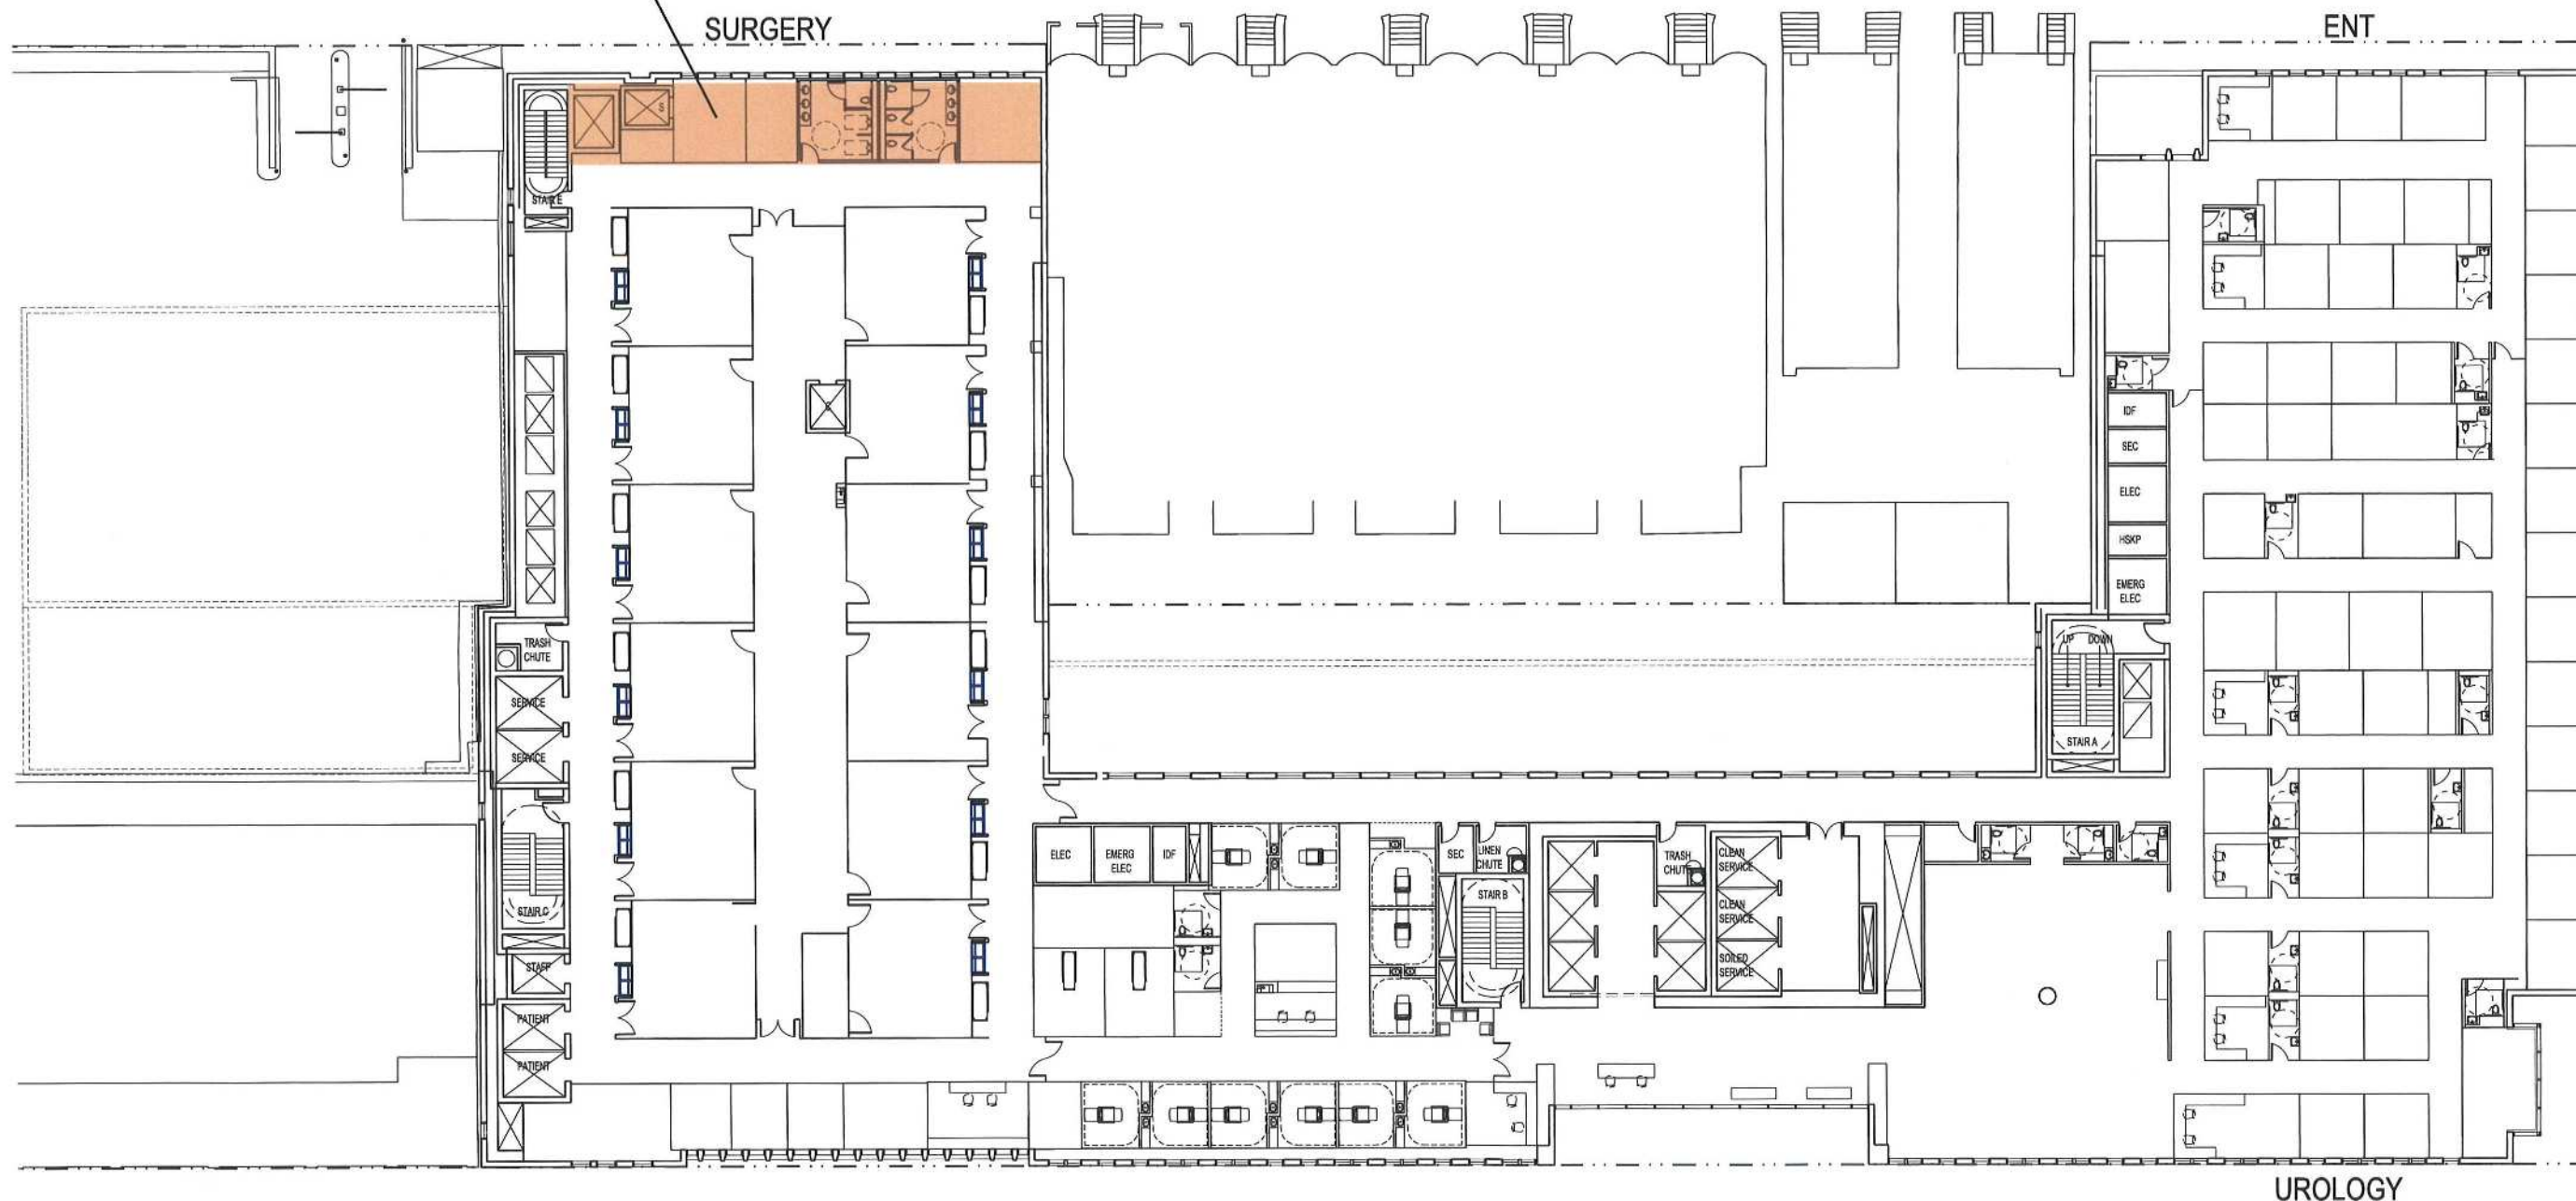
Surgery and support spaces impacted due to required shifting to the south of soiled elevator and support spaces

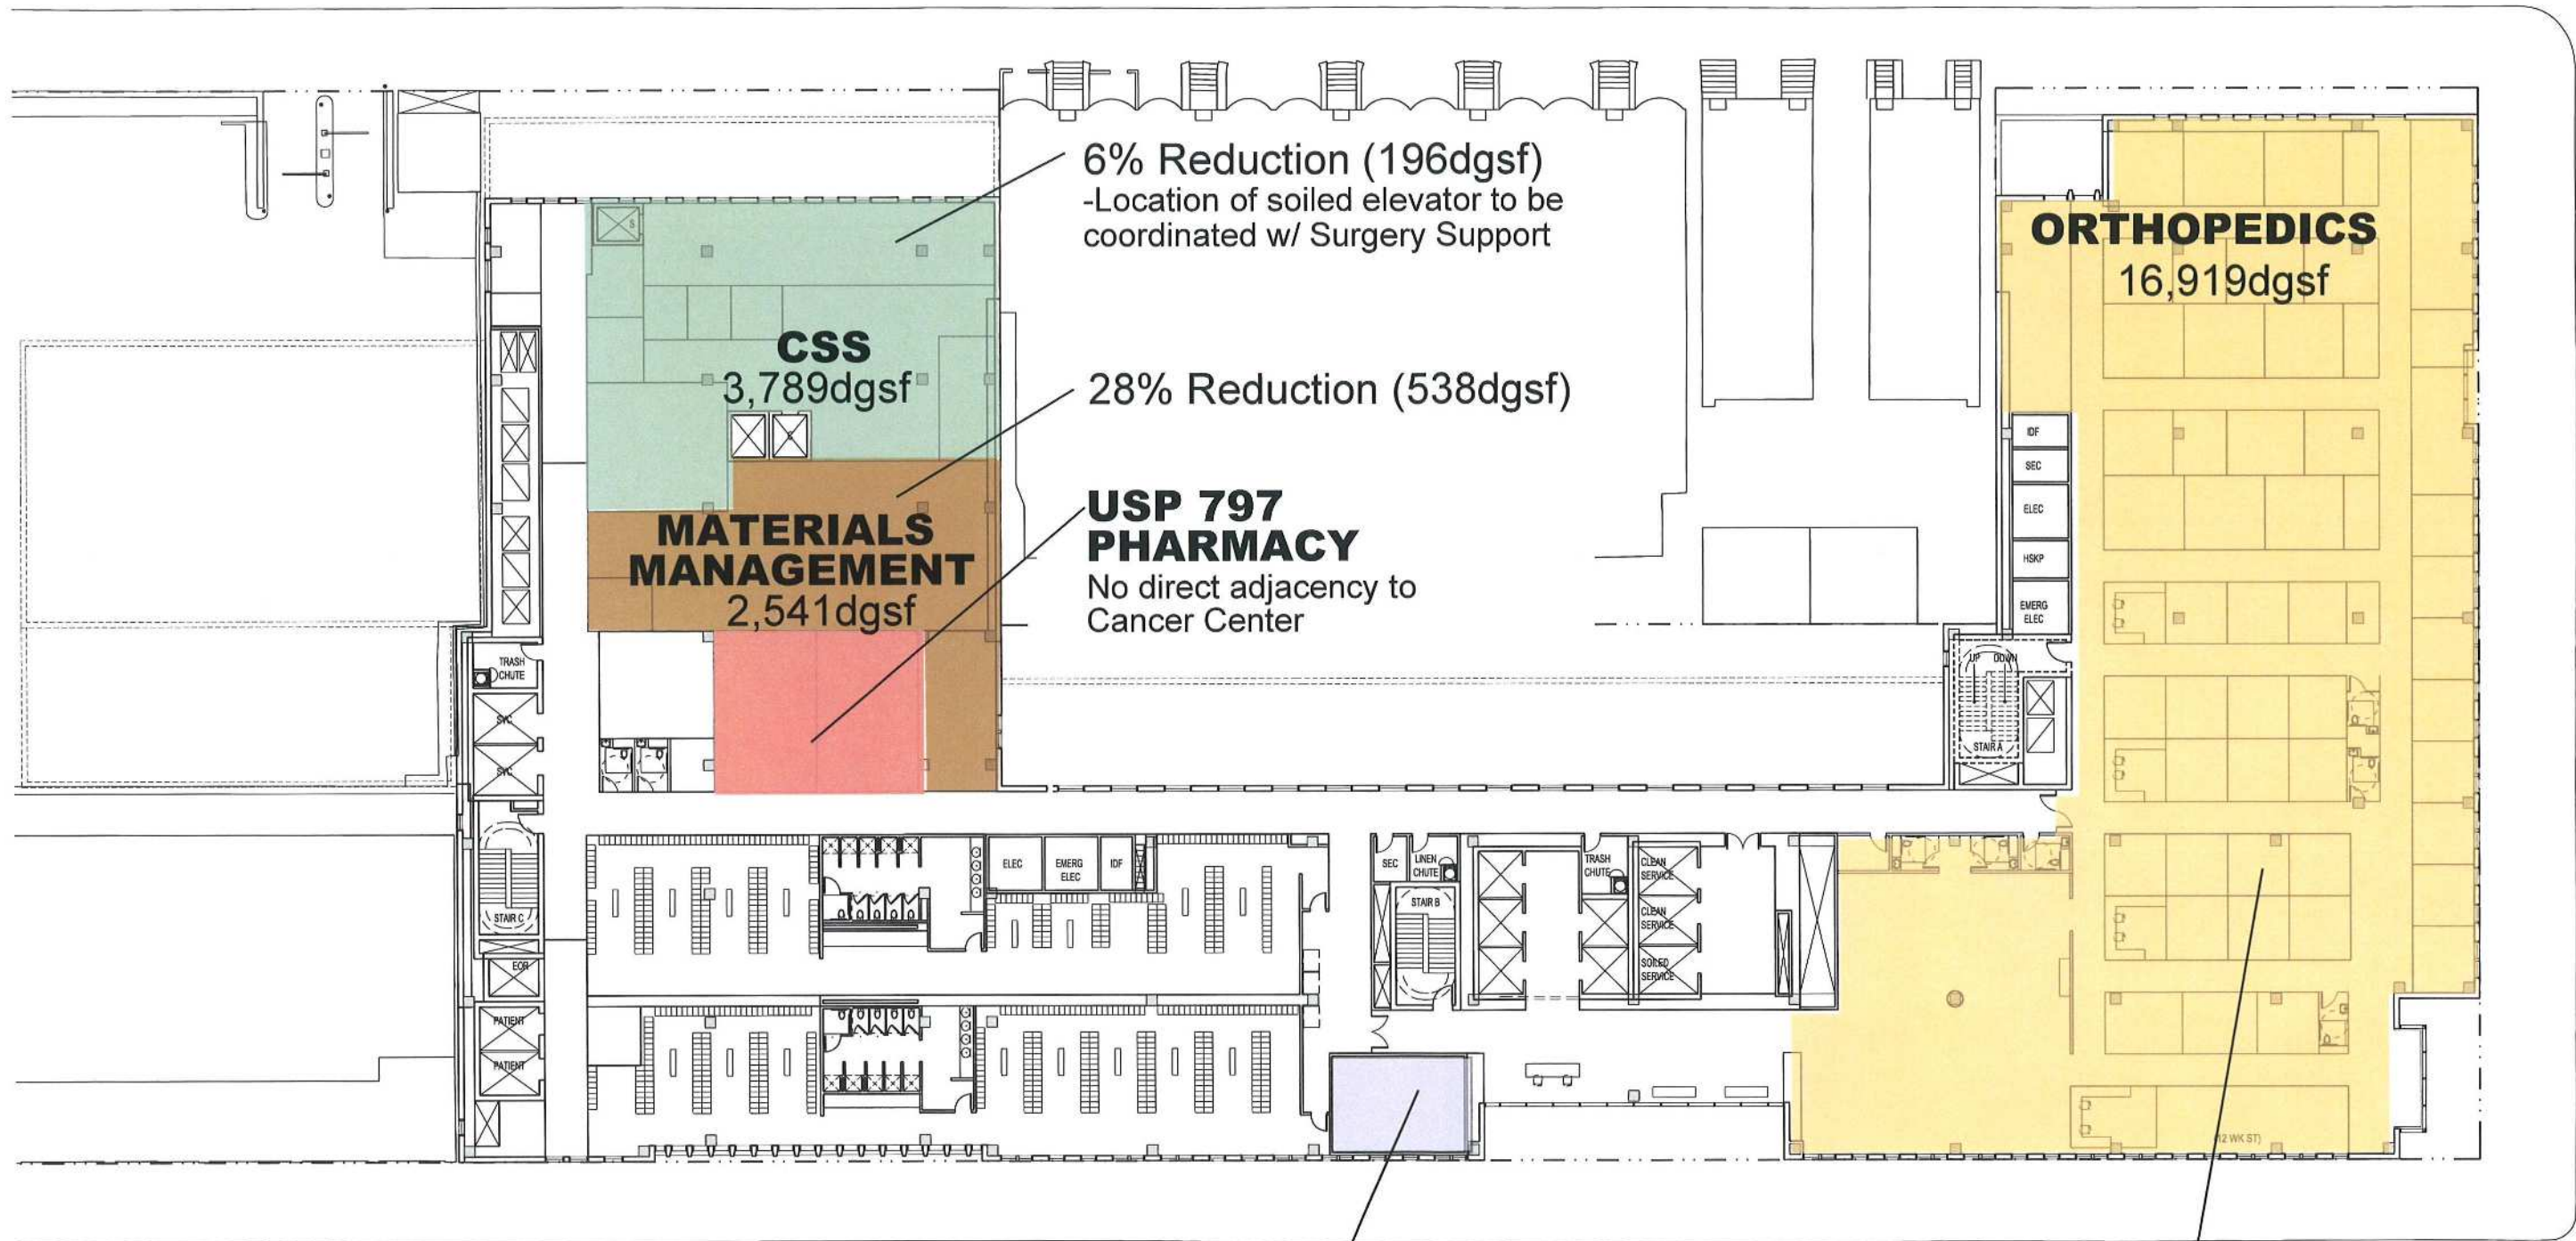
RAPID RESPONSE LAB

No direct adjacency to
Cancer Center

16% Reduction (1,053dgsf)

DEPARTMENT REDUCTIONS:
CENTRAL STERILE SUPPLY - 3,789dgsf
6% reduction (196dgsf)
MATERIALS MANAGEMENT - 2,541dgsf
28% reduction (538dgsf)
ORTHOPEDICS CLINIC - 16,919dgsf
16% reduction (1,053dgsf)
CARDIOLOGY CLINIC - 9,323dgsf
25% reduction (2,958dgsf)
CANCER CENTER - 19,392
38% reduction (11,463dgsf)
WOMEN'S CENTER - 13,693dgsf
15% reduction (2,343dgsf)
TOTAL DEPARTMENTAL GROSS SF REDUCTION:
-23,356dgsf

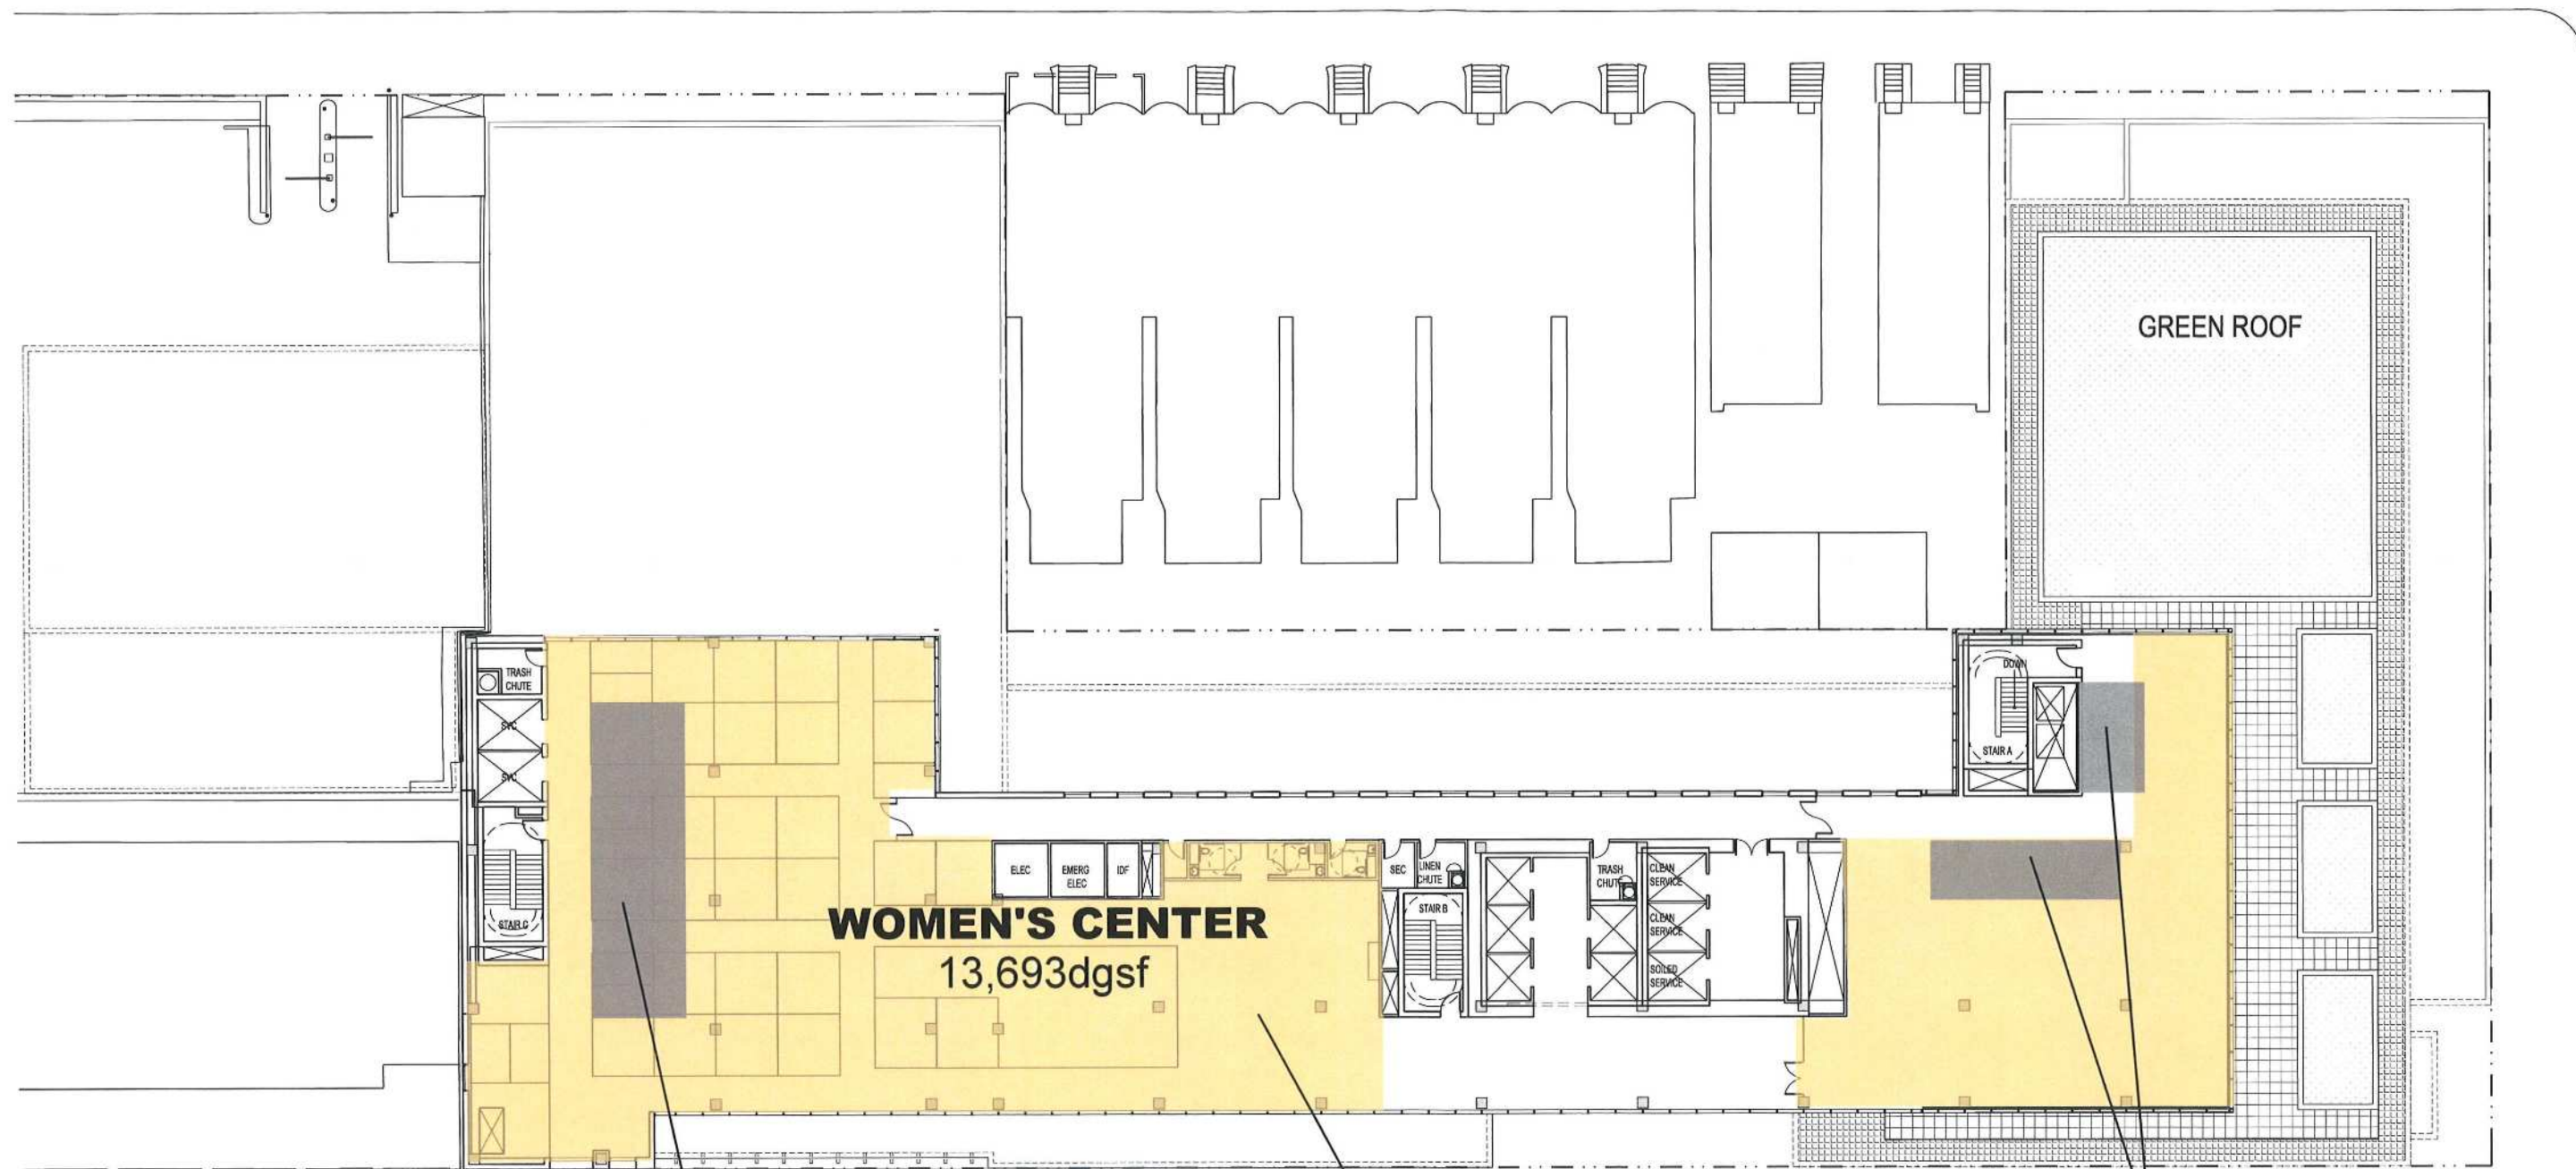
Displaced Mechanical
and Electrical

15% Reduction (2,343dgsf)
-Department split across circulation
core creating less efficiency
