Re: New York Methodist Hospital
Center for Community Health
505-525 6th Street (Block 1084,
Lots 25, 26, 28, 39-44, 46, 48,
50-59, 164, 1001, and 1002)
BSA Cal. No. 289-13-BZ

1. *Provide studies for lesser variance options for the Center that (i) fully comply with the applicable height and setback regulations in the R7B district and (ii) reduce the degree of the building's non-compliance with the applicable height and setback regulations in the R6B district.*

NEW YORK METHODIST HOSPITAL CENTER FOR COMMUNITY HEALTH

LESSER VARIANCE STUDY

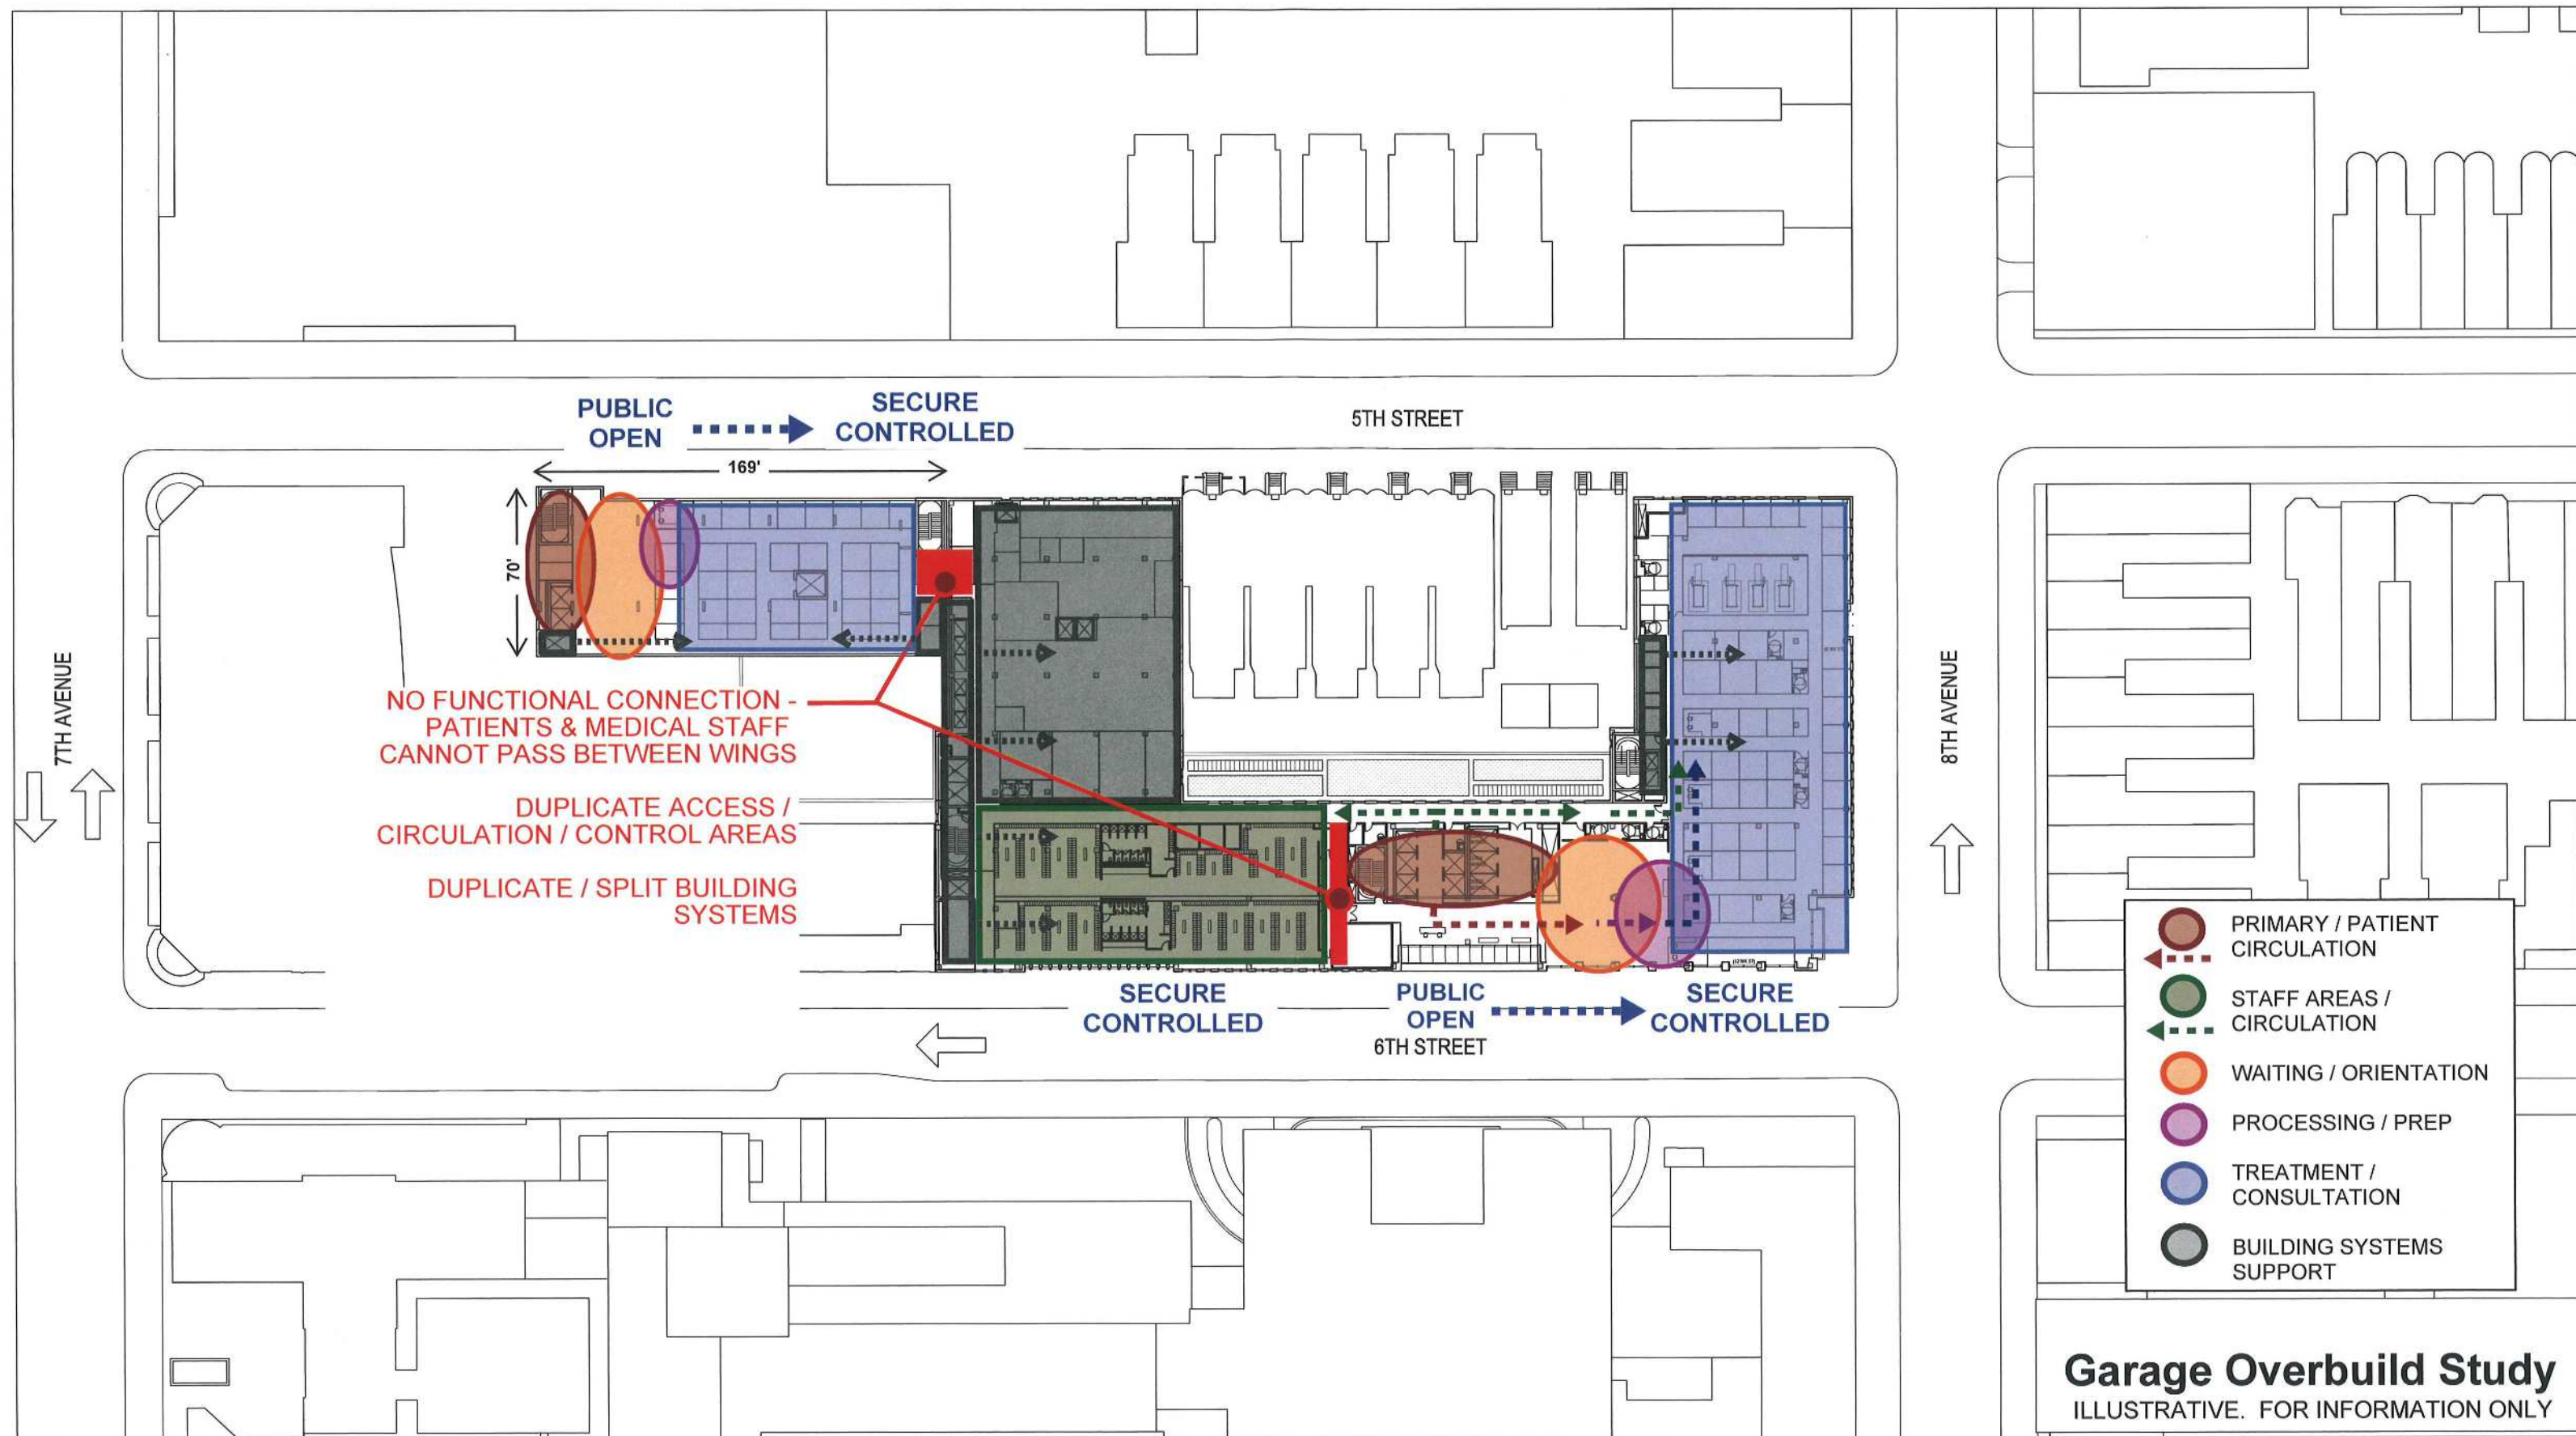
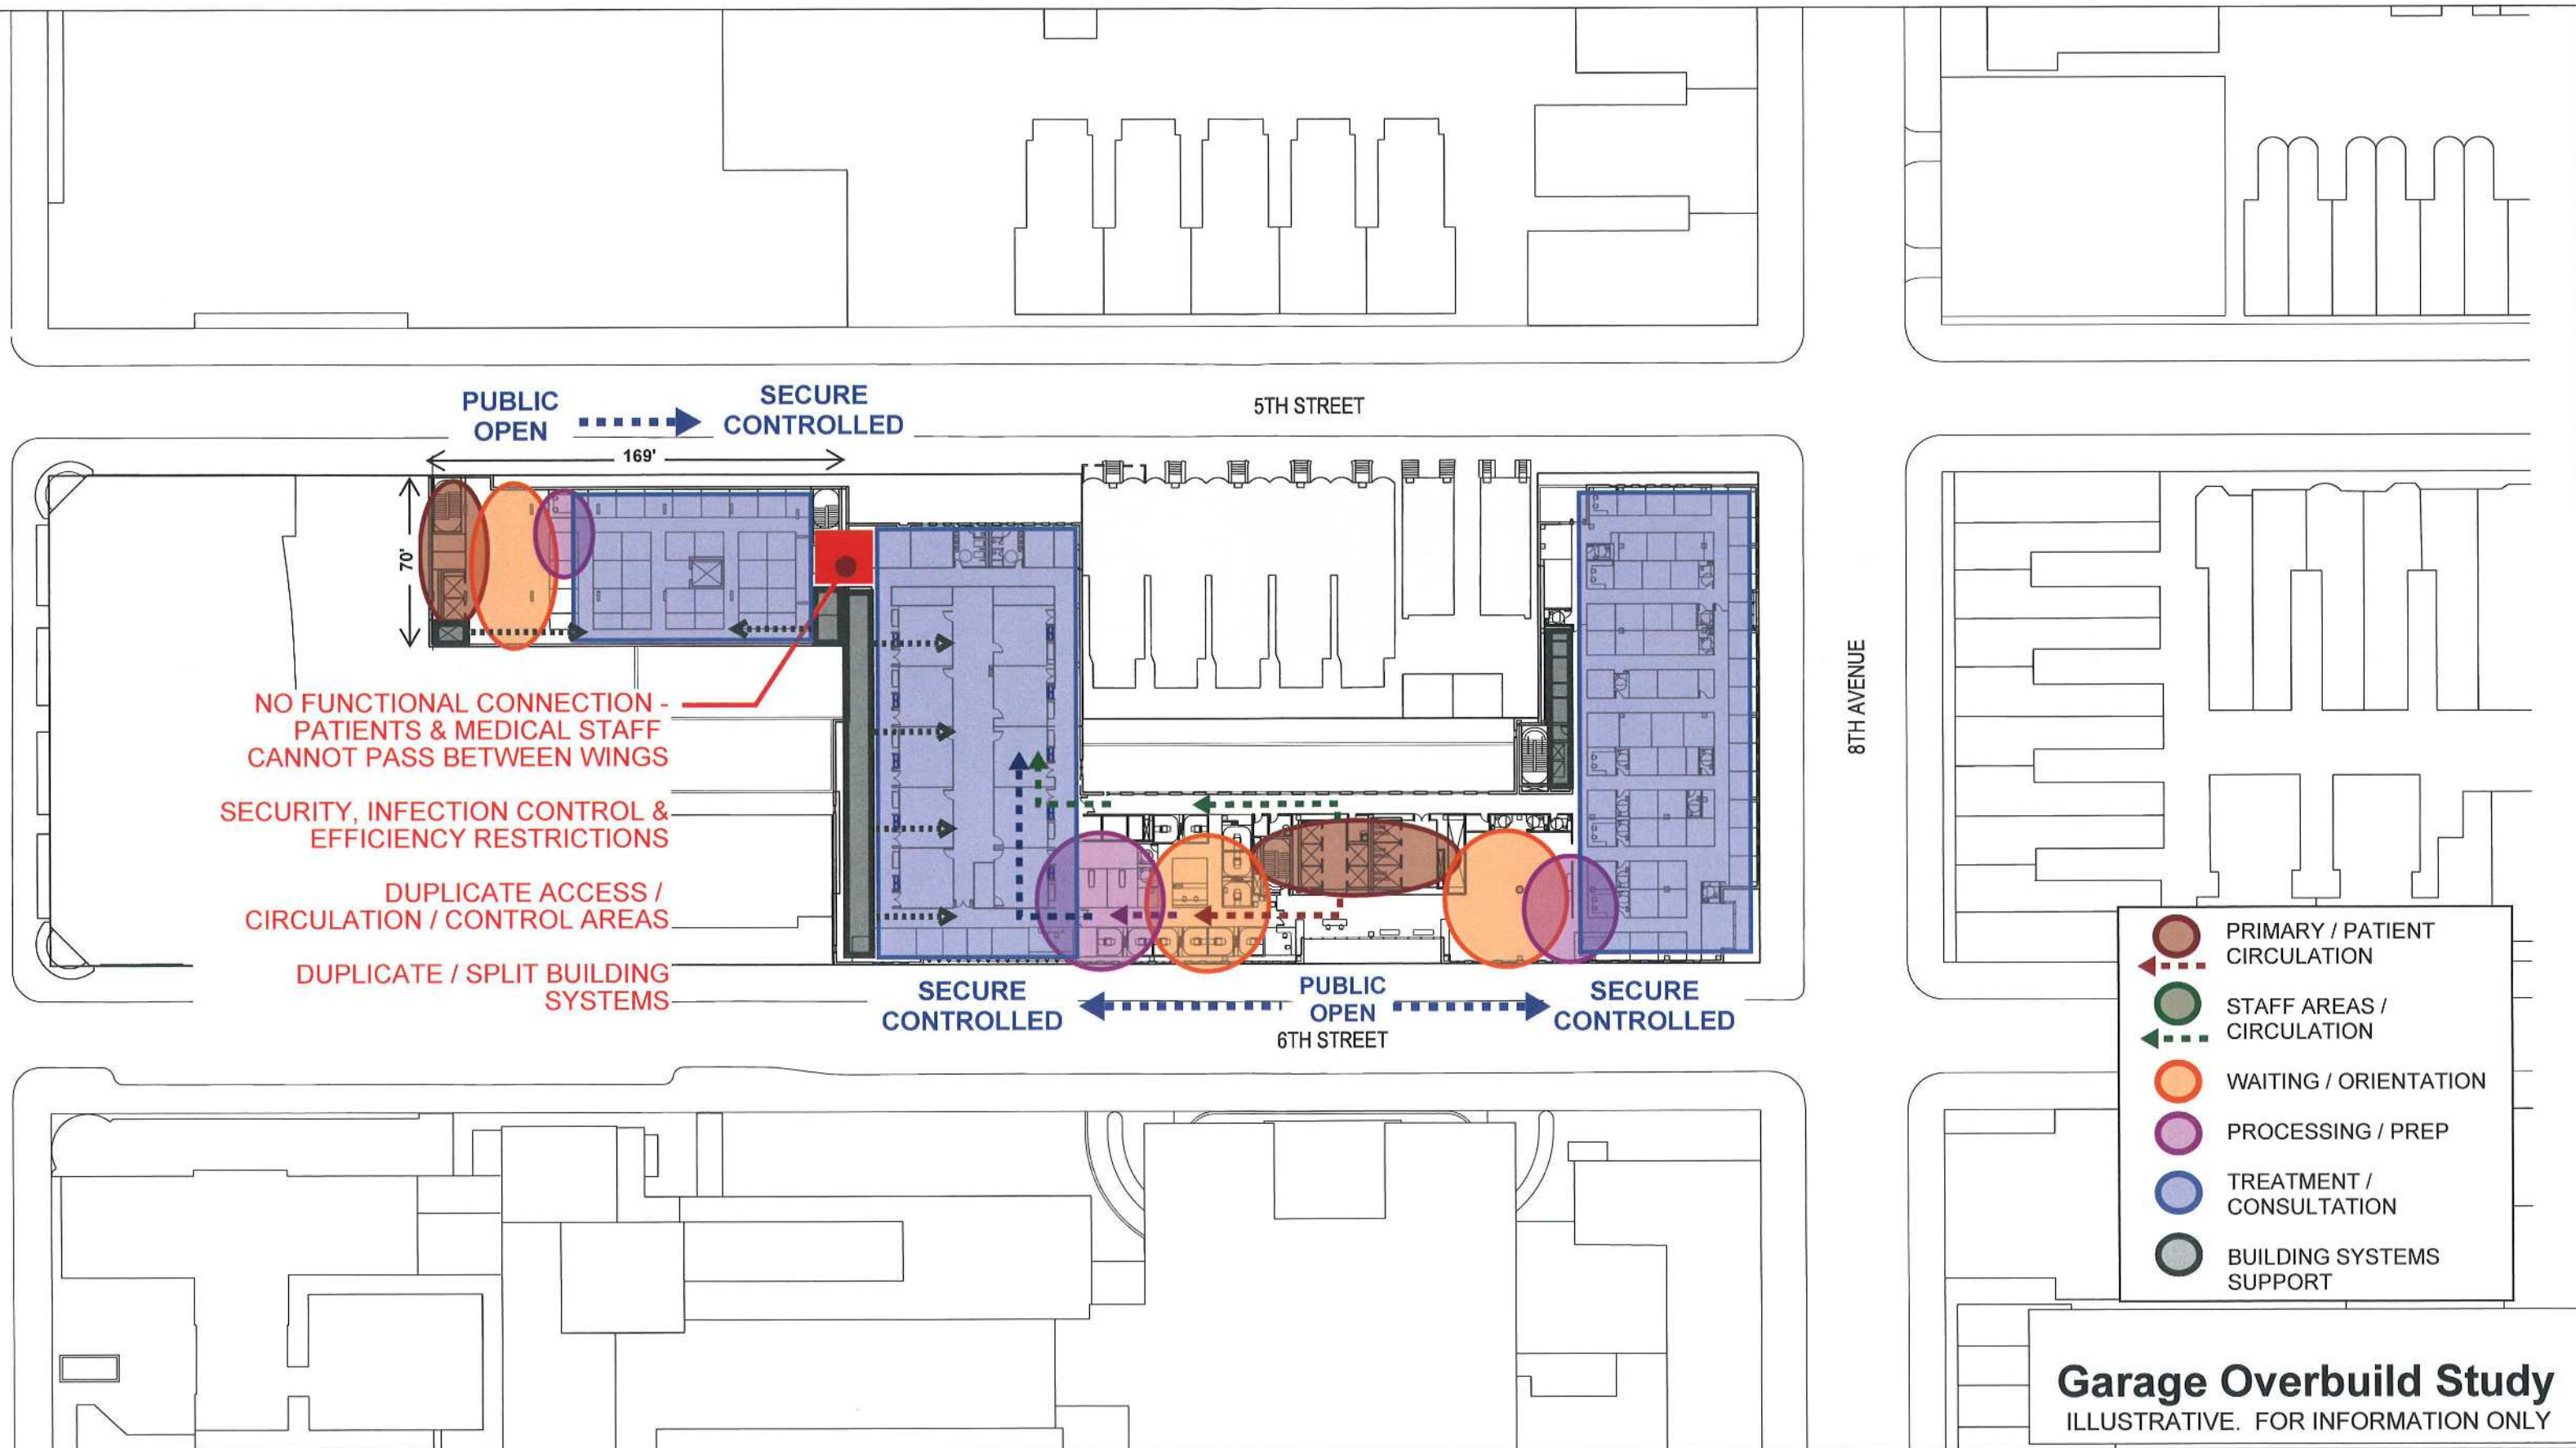
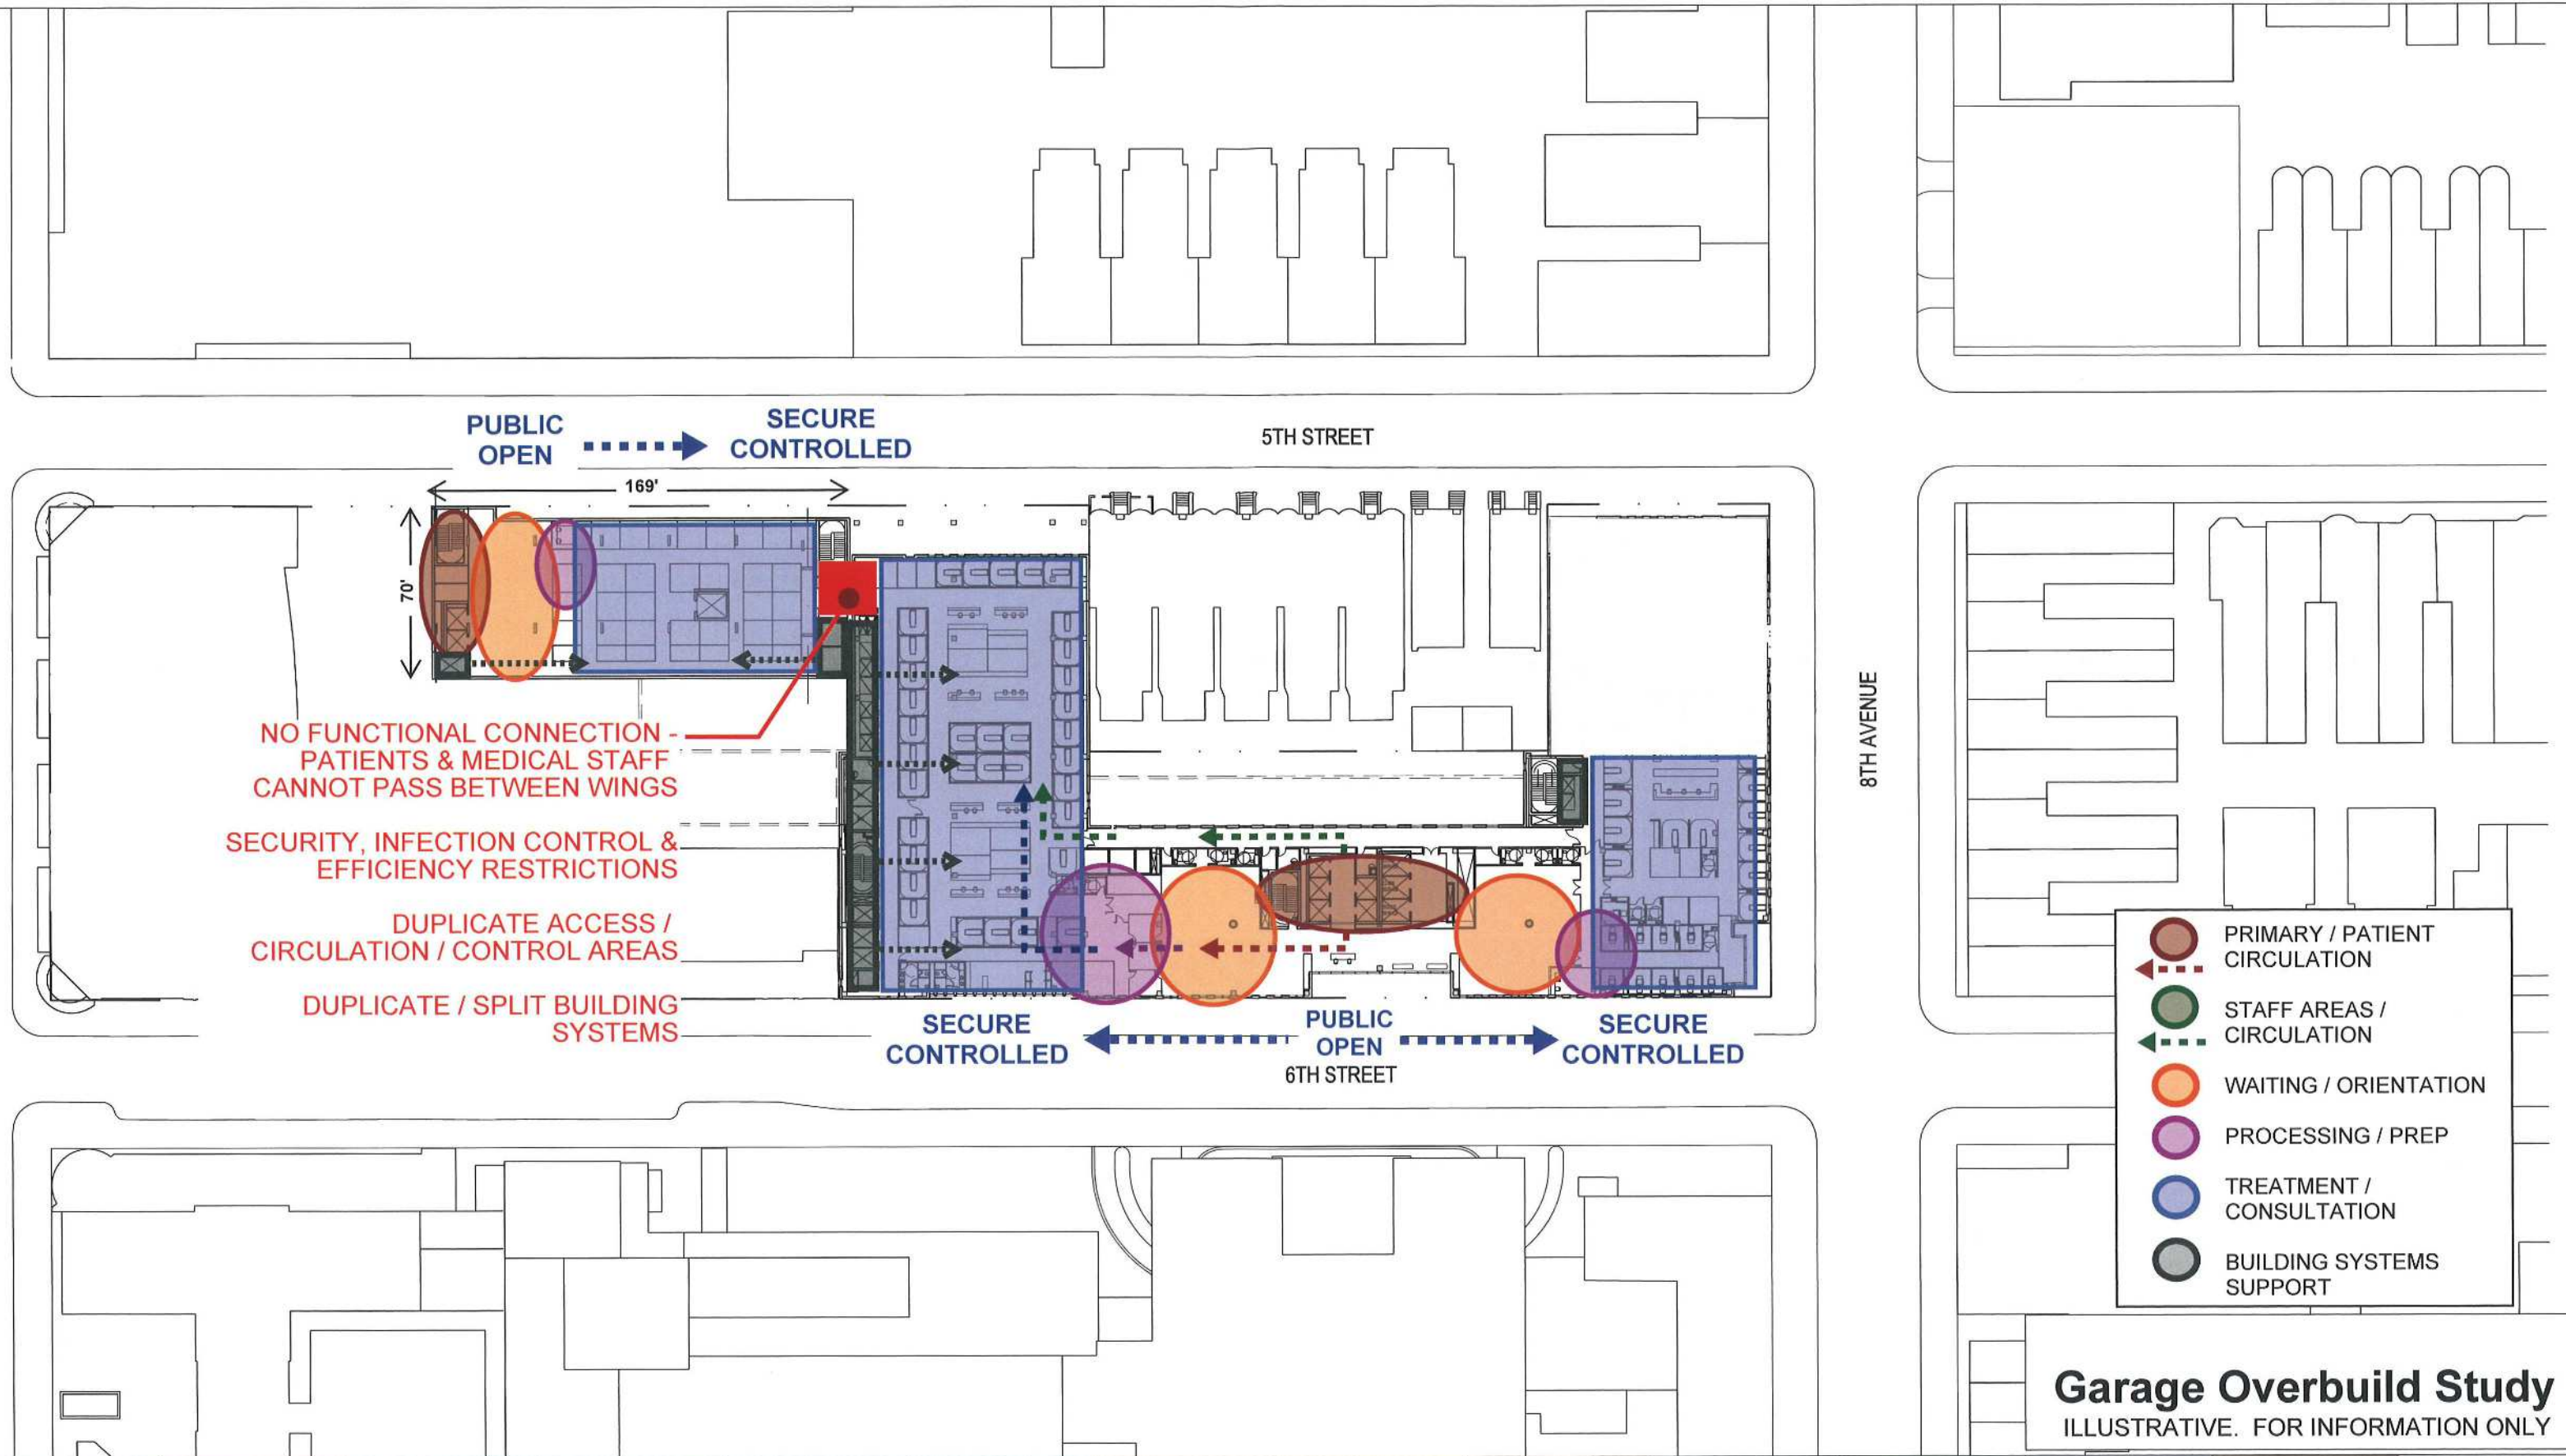
Garage Overbuild Study
ILLUSTRATIVE. FOR INFORMATION ONLY

- PRIMARY / PATIENT CIRCULATION
- STAFF AREAS / CIRCULATION
- WAITING / ORIENTATION
- PROCESSING / PREP
- TREATMENT / CONSULTATION
- BUILDING SYSTEMS SUPPORT

The attached Garage Overbuild Study demonstrates the programmatic deficiencies of a development that includes construction over the existing Hospital garage. The proposed design configuration of the Center on the U-shaped development site is based on a design principle by which two distinct circulation paths are provided (i) for patients and (ii) for staff, oriented around a centrally located core, with patients led progressively toward more controlled, private, and dedicated spaces—from the waiting area to registration, then to processing, then to preparation, and finally to treatment in the eastern and western wings of the building. This design not only provides a rational, efficient circulation network, but it is also needed to accommodate certain ambulatory care facilities in the building. The surgical suite, for example, must be located in the Center's western wing because the central core area and eastern wing do not have sufficient dimensions to accommodate the facilities. The PACU unit and CSS, which must be adjacent to the surgical suite, are therefore also located in the western wing, on the floors immediately above and below.

Such a design would also require an additional vehicular drop-off and pedestrian entrance on 5th Street, since almost all of the garage wing's floors, including the ground floor, could not be accessed from the building's central circulation core on 6th Street. This configuration would require an inefficient utilization of space, with more area dedicated to vertical and horizontal circulation and vehicular access, and would result in increased vehicular traffic on 5th Street. (See Ground Floor Plan Diagram) In short, the building would have the same deficiencies as the Complying Development. To the extent that the garage wing complied with applicable height and setback and rear yard equivalent regulations, it would similarly contain very narrow floor plates, capable of accommodating only inefficiently small suites for the Hospital's clinical institutes.

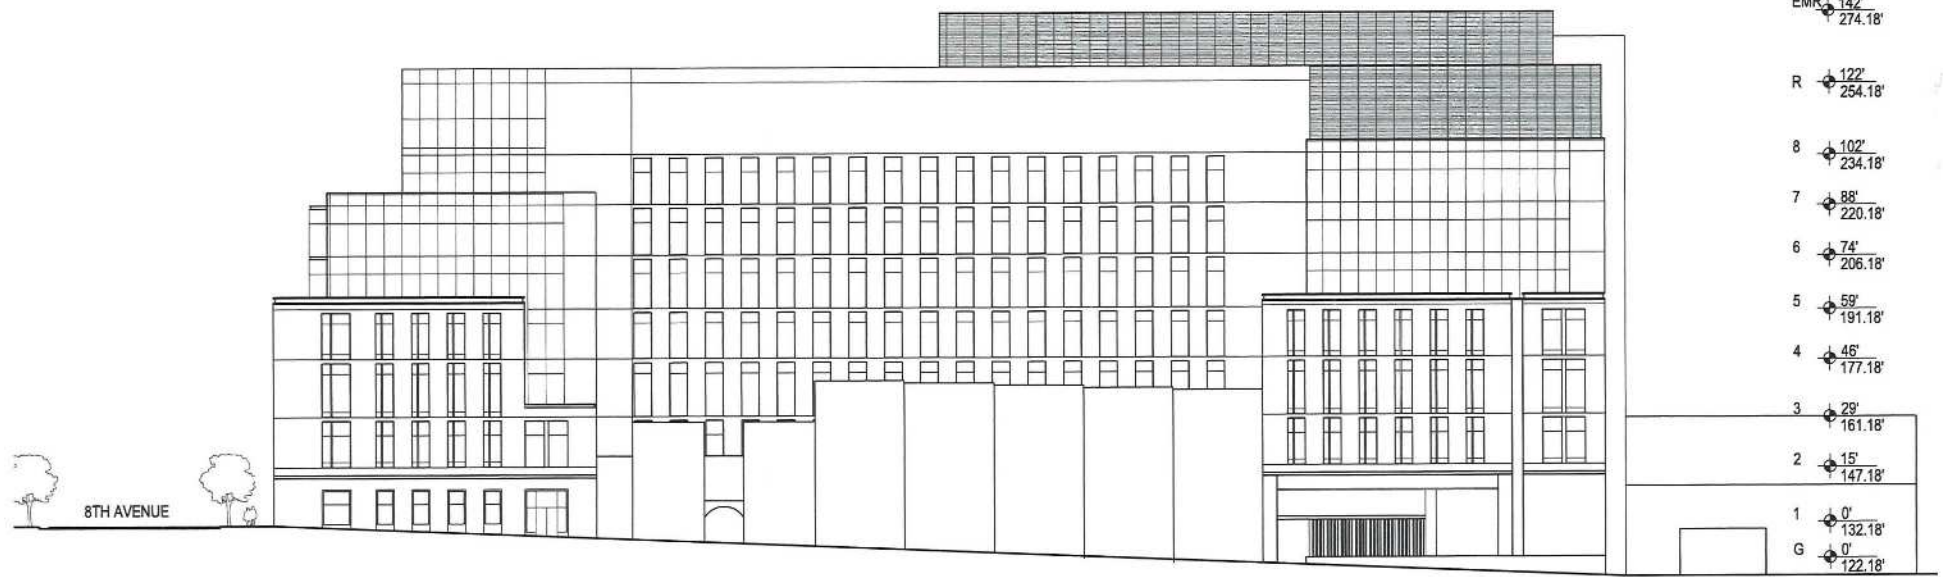
MASSING AS PER 01-28-2014 SUBMITTAL

- The height reduction would in some cases require the flattening of ductwork, resulting in suboptimal height-to-width ratios. Such ratios would result in increased surface friction, requiring either larger fans or increased demands on fans, with the associated wear and tear. They would also result in increased face velocities for air passage in some cases, and in turn reduced patient comfort.

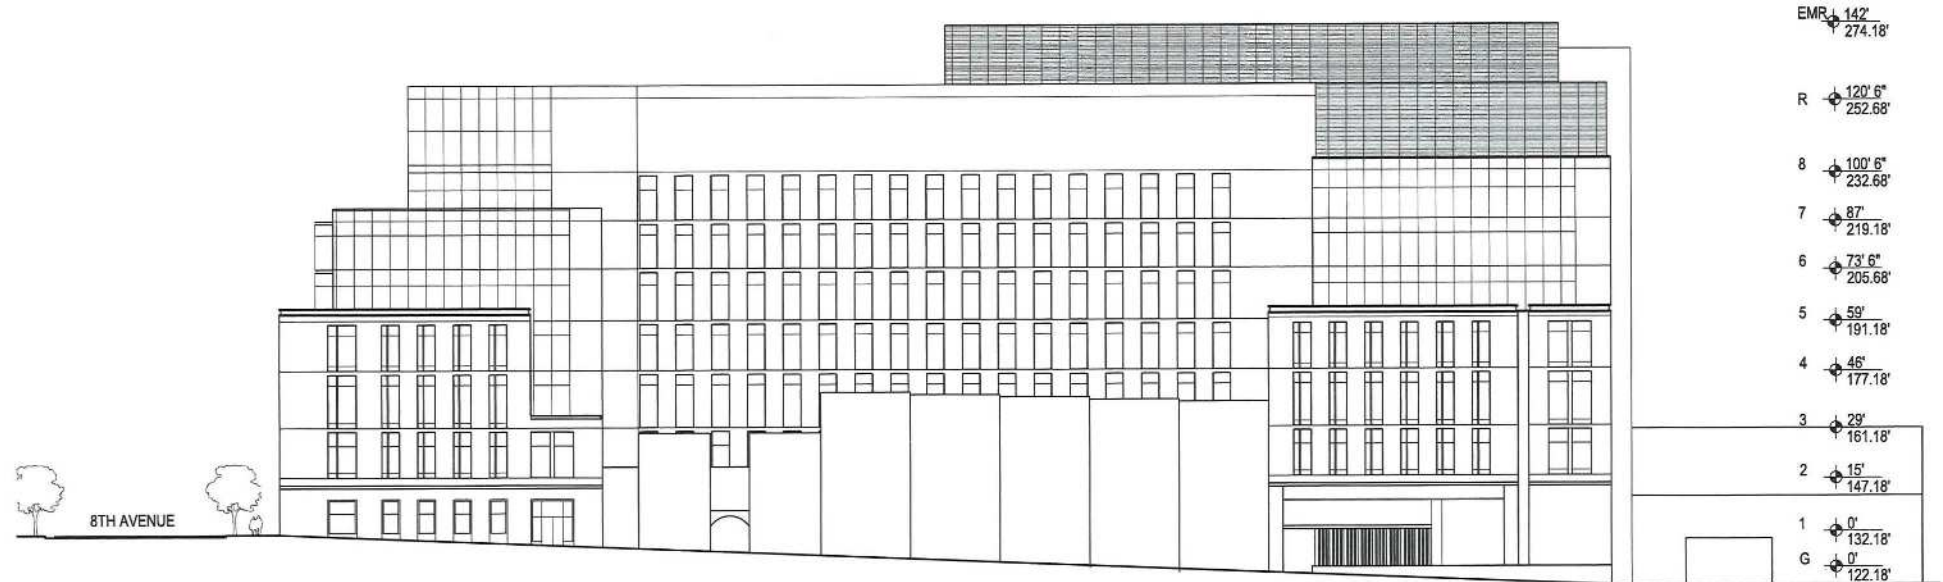
MASSING WITH 5TH-7TH FLOOR HEIGHT REDUCTION

MASSING COMPARISON

NORTH ELEVATION

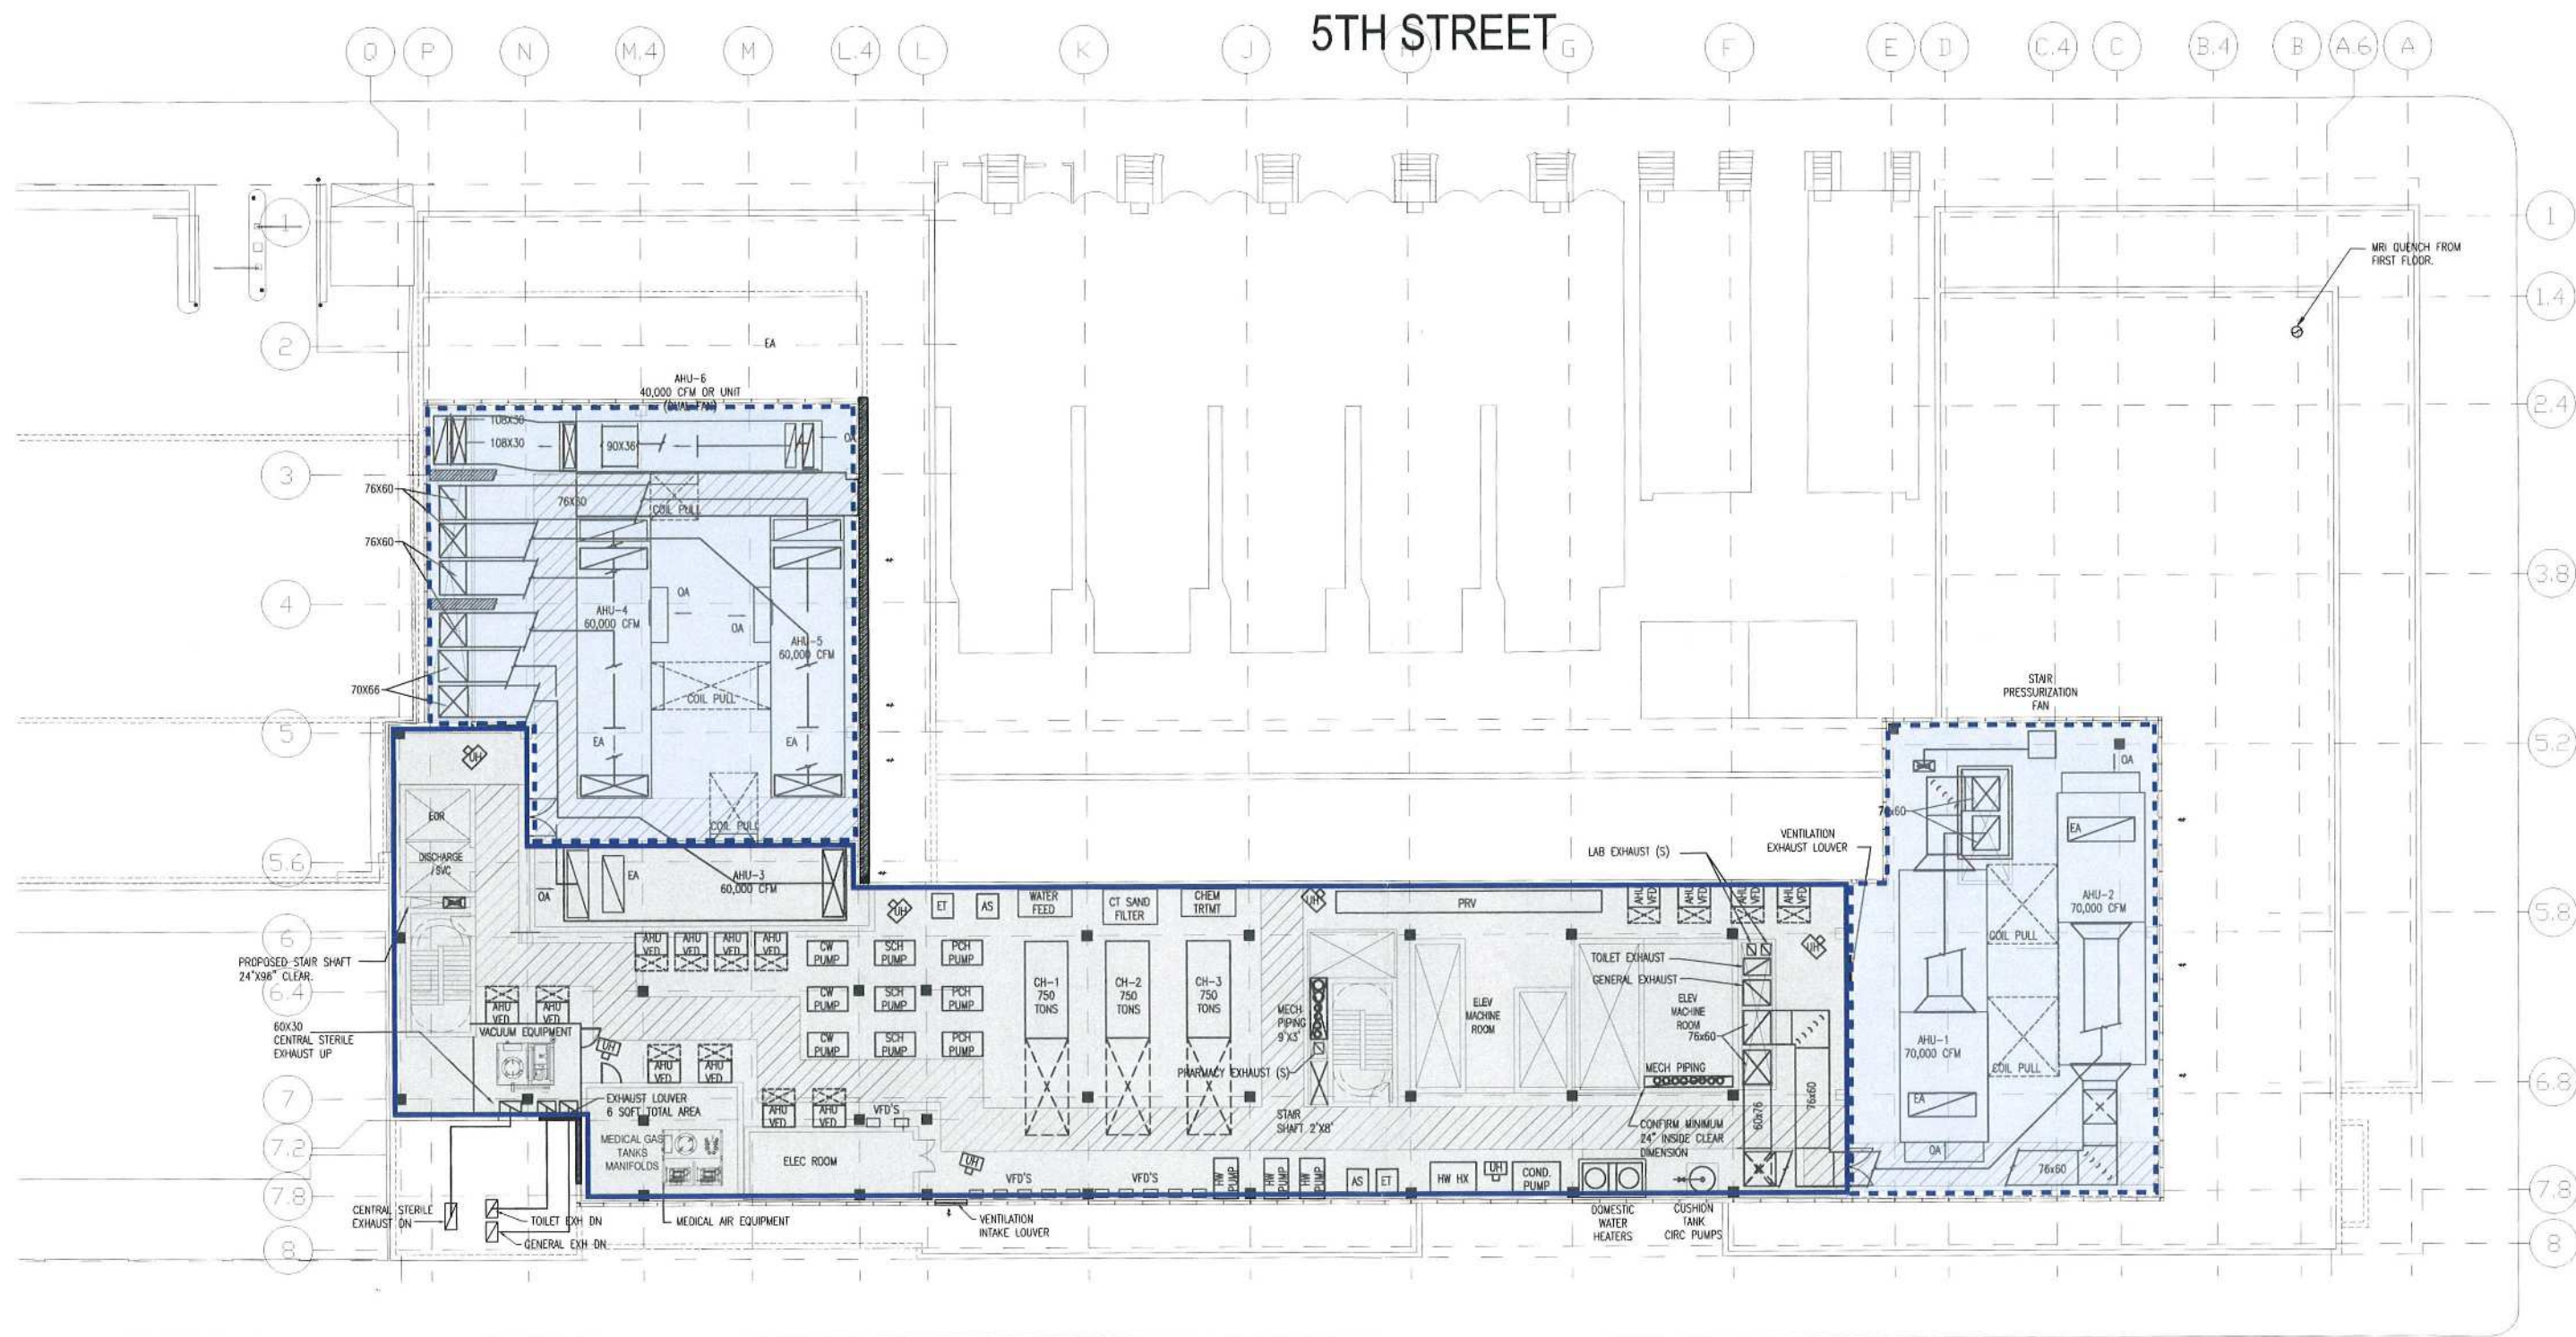
Equipment Screen Study

- Enclosed mechanical area
- Screened mechanical area

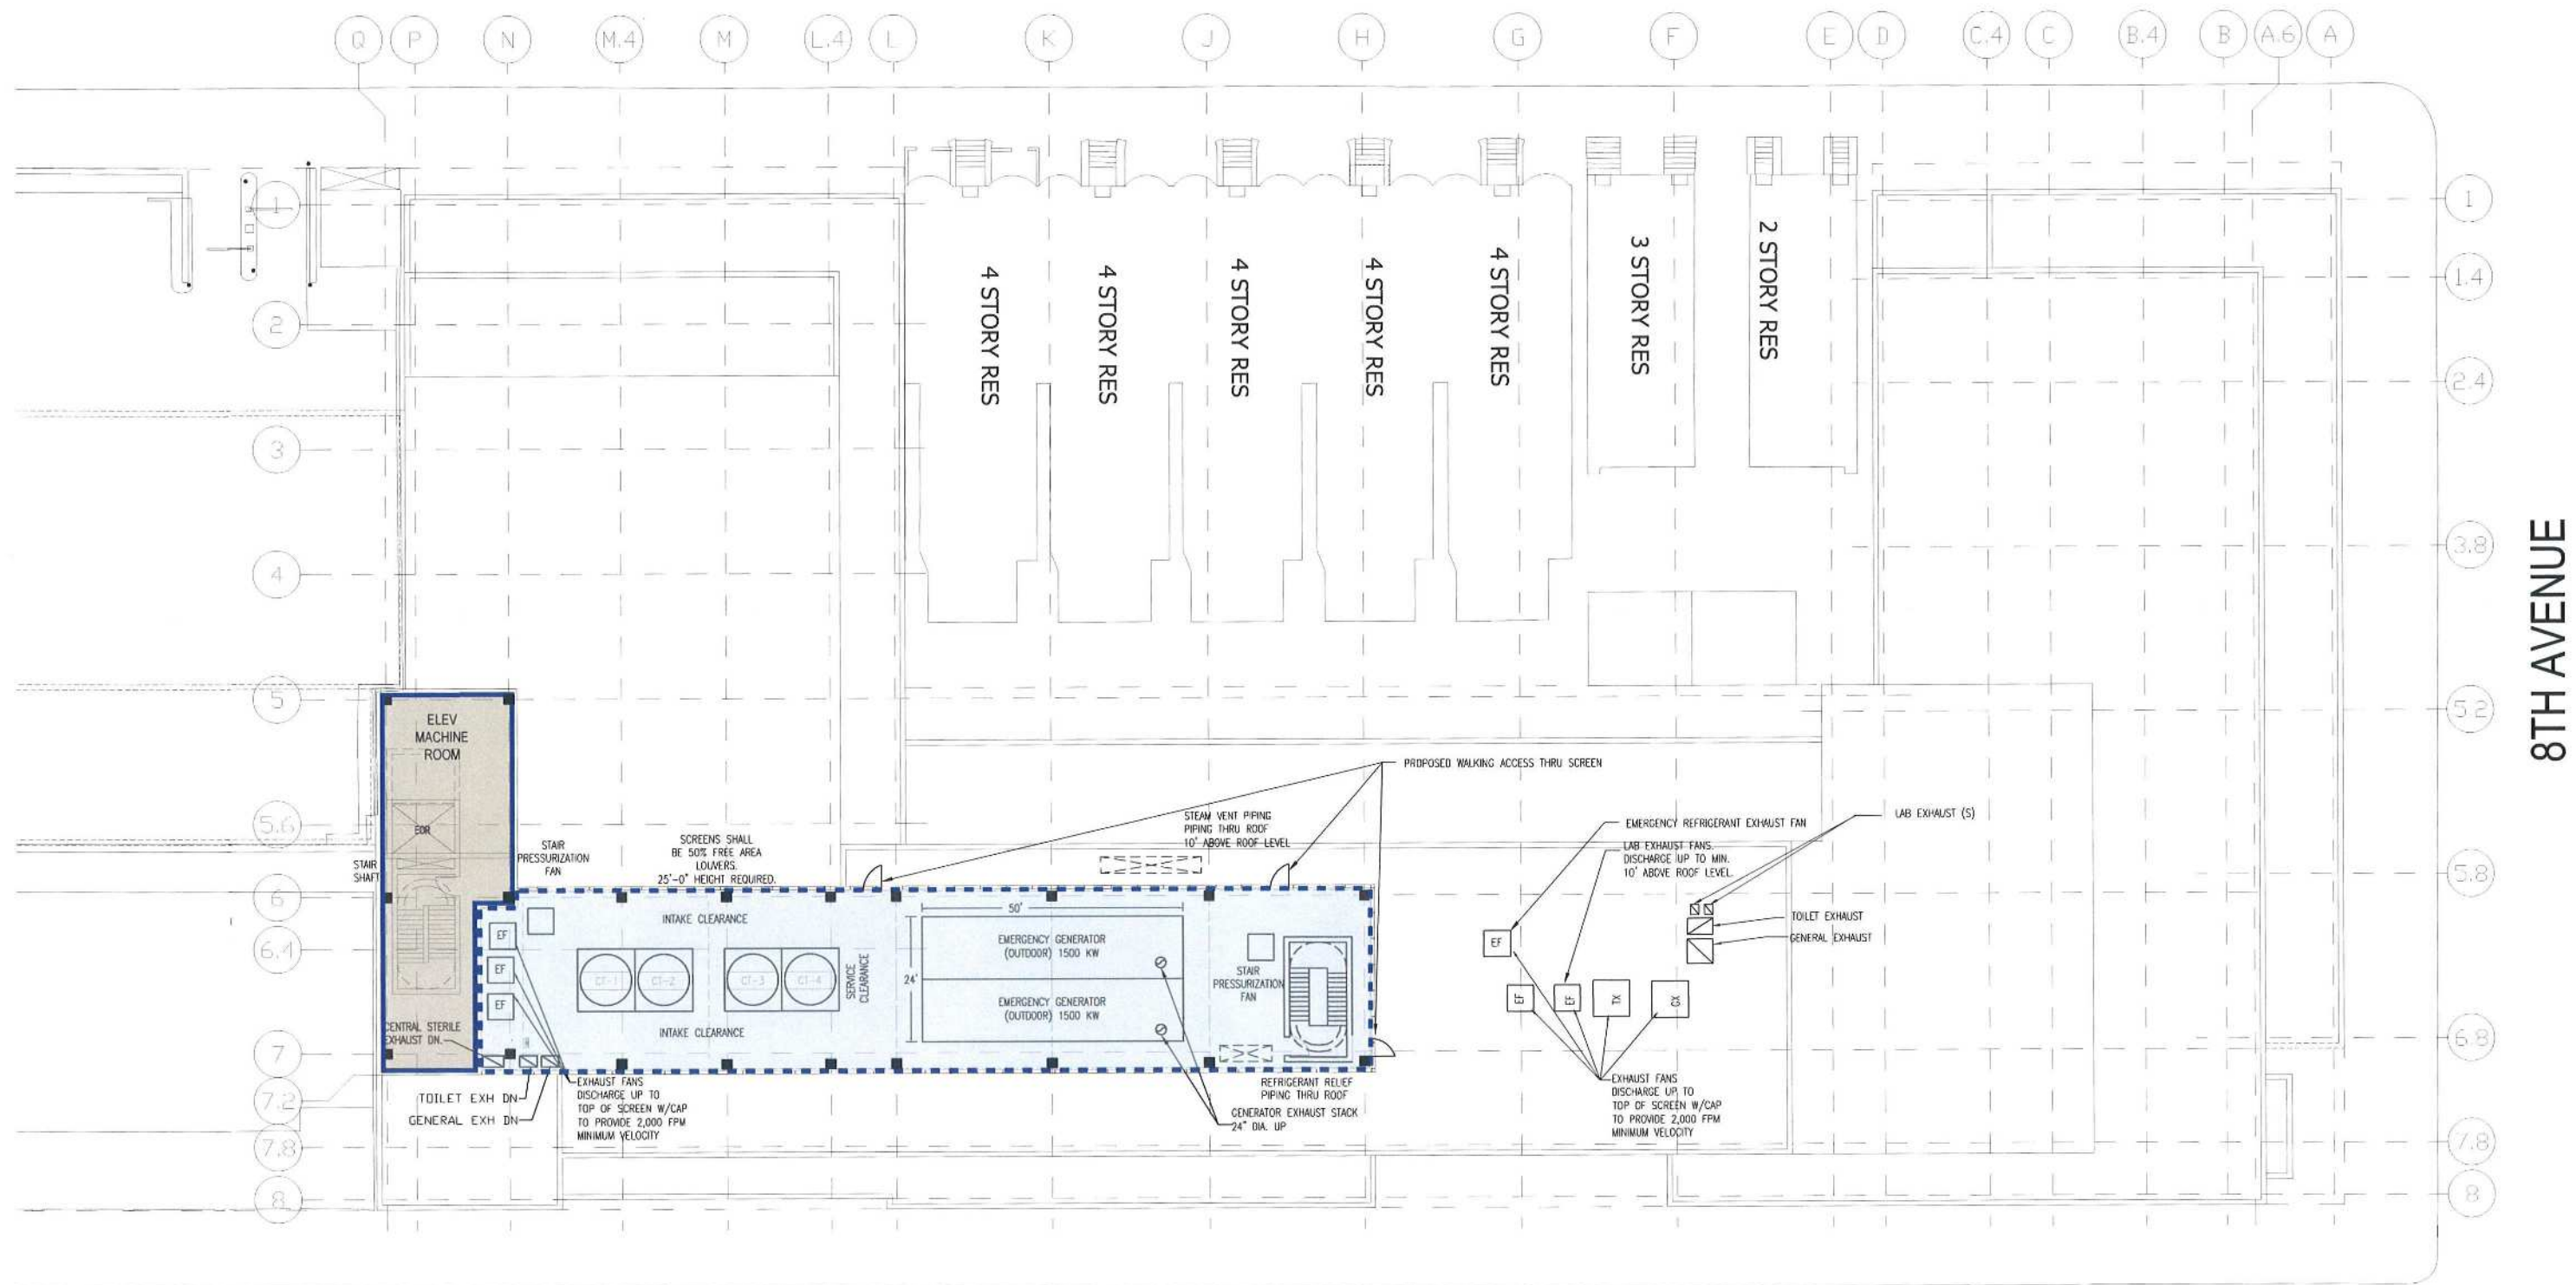
Equipment Screen Study

- Enclosed mechanical area
- Screened mechanical area
